Contract #: 04-0120F4Cty: SF/ALA Rte: 80 PM: 13.2/13.9File #: 69.28**WELDING INSPECTION REPORT****Resident Engineer:**Siegenthaler, Peter**Address:** 333 Burma Road**City:** Oakland, CA 94607**Report No:** WIR-020765**Date Inspected:** 20-Feb-2011**Project Name:** SAS Superstructure**OSM Arrival Time:** 700**Prime Contractor:** American Bridge/Fluor Enterprises, a JV**OSM Departure Time:** 1900**Contractor:** Zhenhua Port Machinery Company, Ltd (ZPMC), Changxing Island **Location:** Shanghai, China**CWI Name:** Qiu Wen.**CWI Present:** Yes No**Inspected CWI report:** Yes No N/A**Rod Oven in Use:** Yes No N/A**Electrode to specification:** Yes No N/A**Weld Procedures Followed:** Yes No N/A**Qualified Welders:** Yes No N/A**Verified Joint Fit-up:** Yes No N/A**Approved Drawings:** Yes No N/A**Approved WPS:** Yes No N/A**Delayed / Cancelled:** Yes No N/A**Bridge No:** 34-0006**Component:** OBG components.**Summary of Items Observed:**

On this day CALTRANS OSM Quality Assurance Inspector (QA) Mr. Shailesh Wadkar was present during the times noted above for observations relative to the fabrication of the Self Anchored Suspension (SAS)

Superstructure being performed by Zhenhua Port Mac

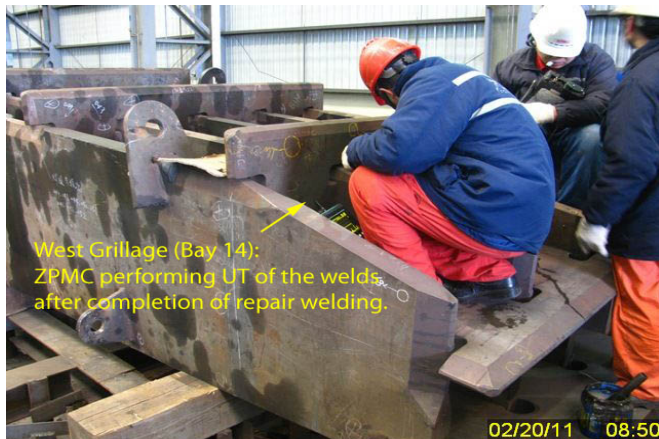
ZPMC personnel performing Ultrasonic Testing of weld joint nos: SA712C-265 and 259, complete joint penetration (CJP) weld, after repair welding. ZPMC Quality Control (QC) was identified as Jen Jei Wei. See attached photo for further information.

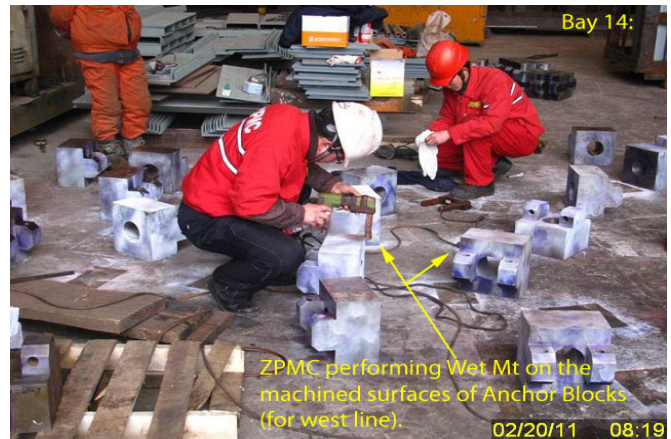
This QA Inspector observed ZPMC personnel performing Wet Magnetic particle Testing on Anchor Blocks (for West line). See attached photo for further information.
